RAILWAY ACCIDENTS

REPORT ON THE COLLISION

which occurred on
4th December 1957

**ST. JOHNS STATION
LEWISHAM**

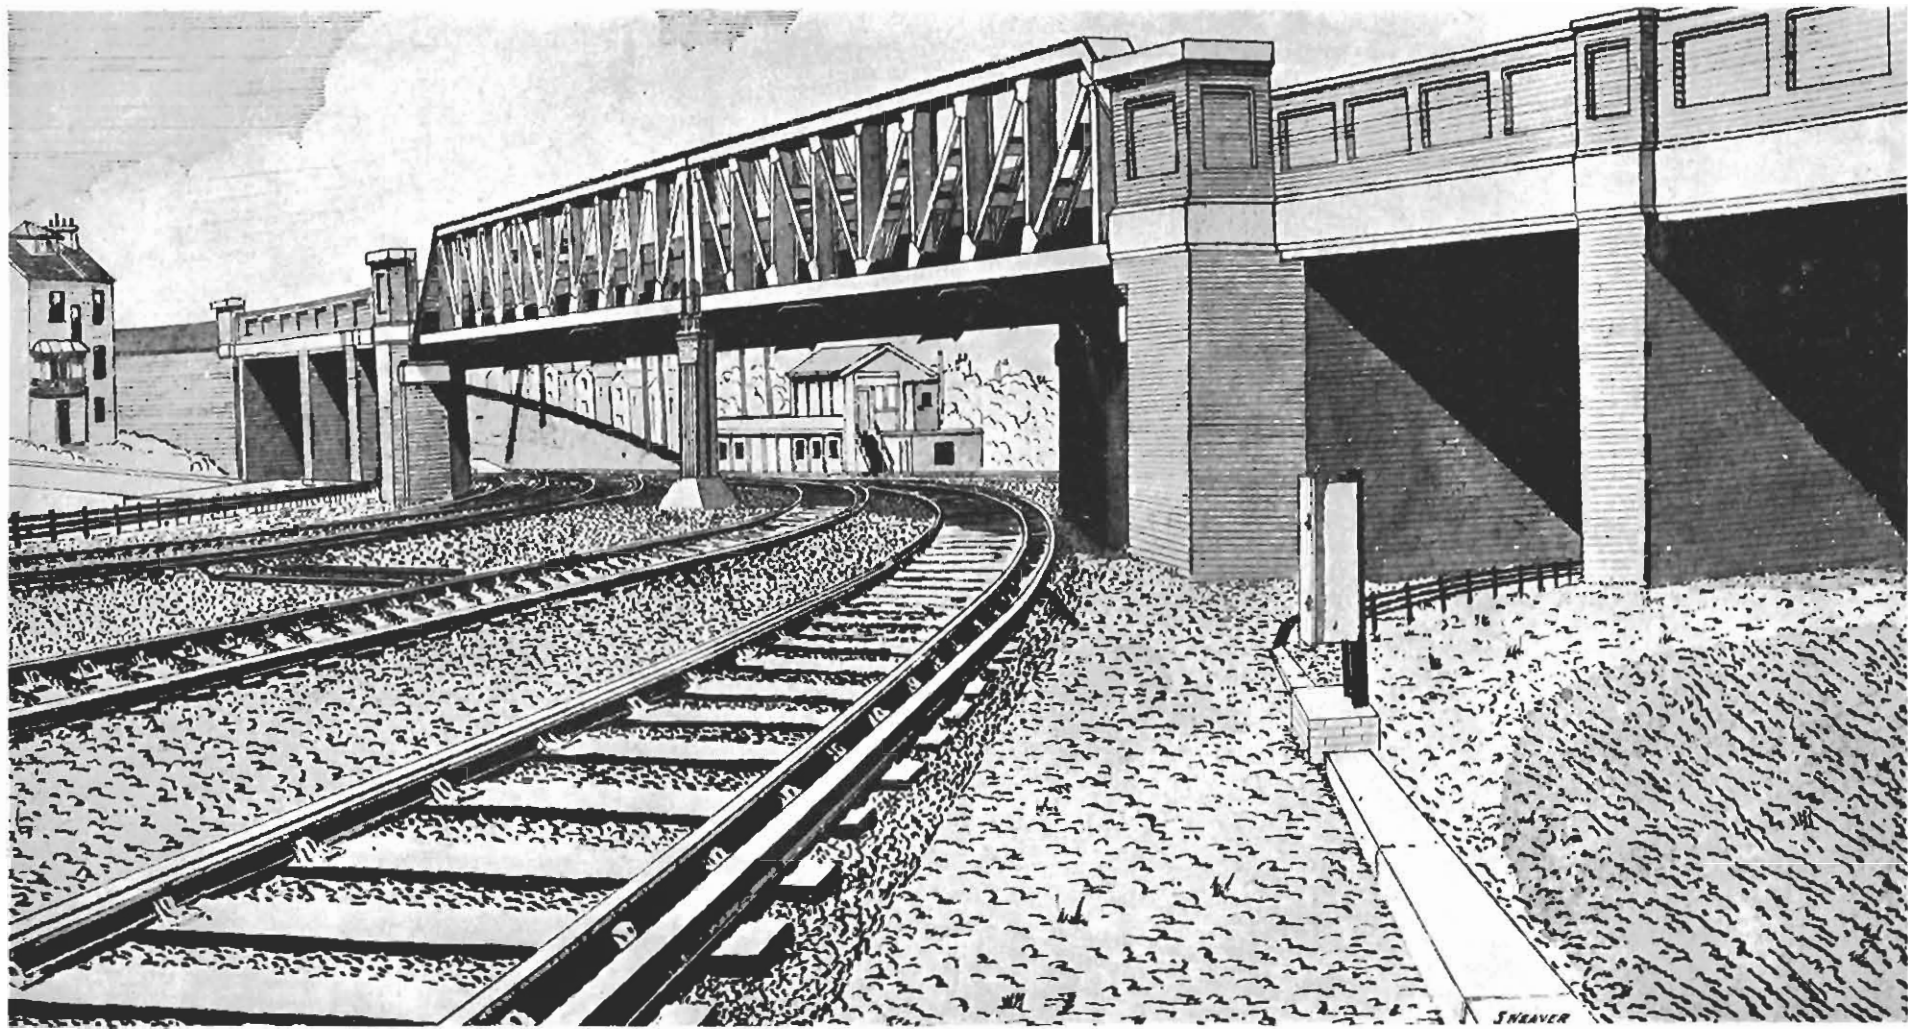
The stanchion supporting the inner ends of the two London side girders consisted of a pair of steel columns close together, each fabricated of rolled steel joists. The stanchion supporting the girders on the country side, which was knocked over, was a single and stouter column, also built up from steel joists, and it carried a dead load of approximately 120 tons—see Fig. 4. Its length parallel to the track and its width were 5 ft. 0 ins. and 2 ft. 0 ins. respectively. With the cast iron cap and fabricated base the height of the column was 15 ft. 0 ins. above the heavy and deep concrete foundation to which it was secured by four 1½ ins. bolts. The weight of the column and its fabricated concrete-filled base was approximately 14½ tons.

9. There was no doubt that the first blow on the column had been struck by the left hand corner of the tender, and it appeared that the blow had been centred about 7 ft. 5 ins. above rail level.

As a result, the column was pushed out, head foremost, shearing the four 1½ ins. bolts which attached the cast iron cap, and shearing one and breaking in tension the other three 1½ ins. bolts securing the base to the concrete foundation. The column was then projected forward, probably by the underframe of the leading coach, and it was found on its side in the position shown by Fig. 2 and the photograph, with the base some 20 ft. forward from its original position. It was estimated, with the support of calculations, that the horizontal pressure necessary to strike out and throw forward the column in this way might have been between 215 and 280 tons.

BRIDGE No. 111. VIEWED FROM COUNTRY SIDE.

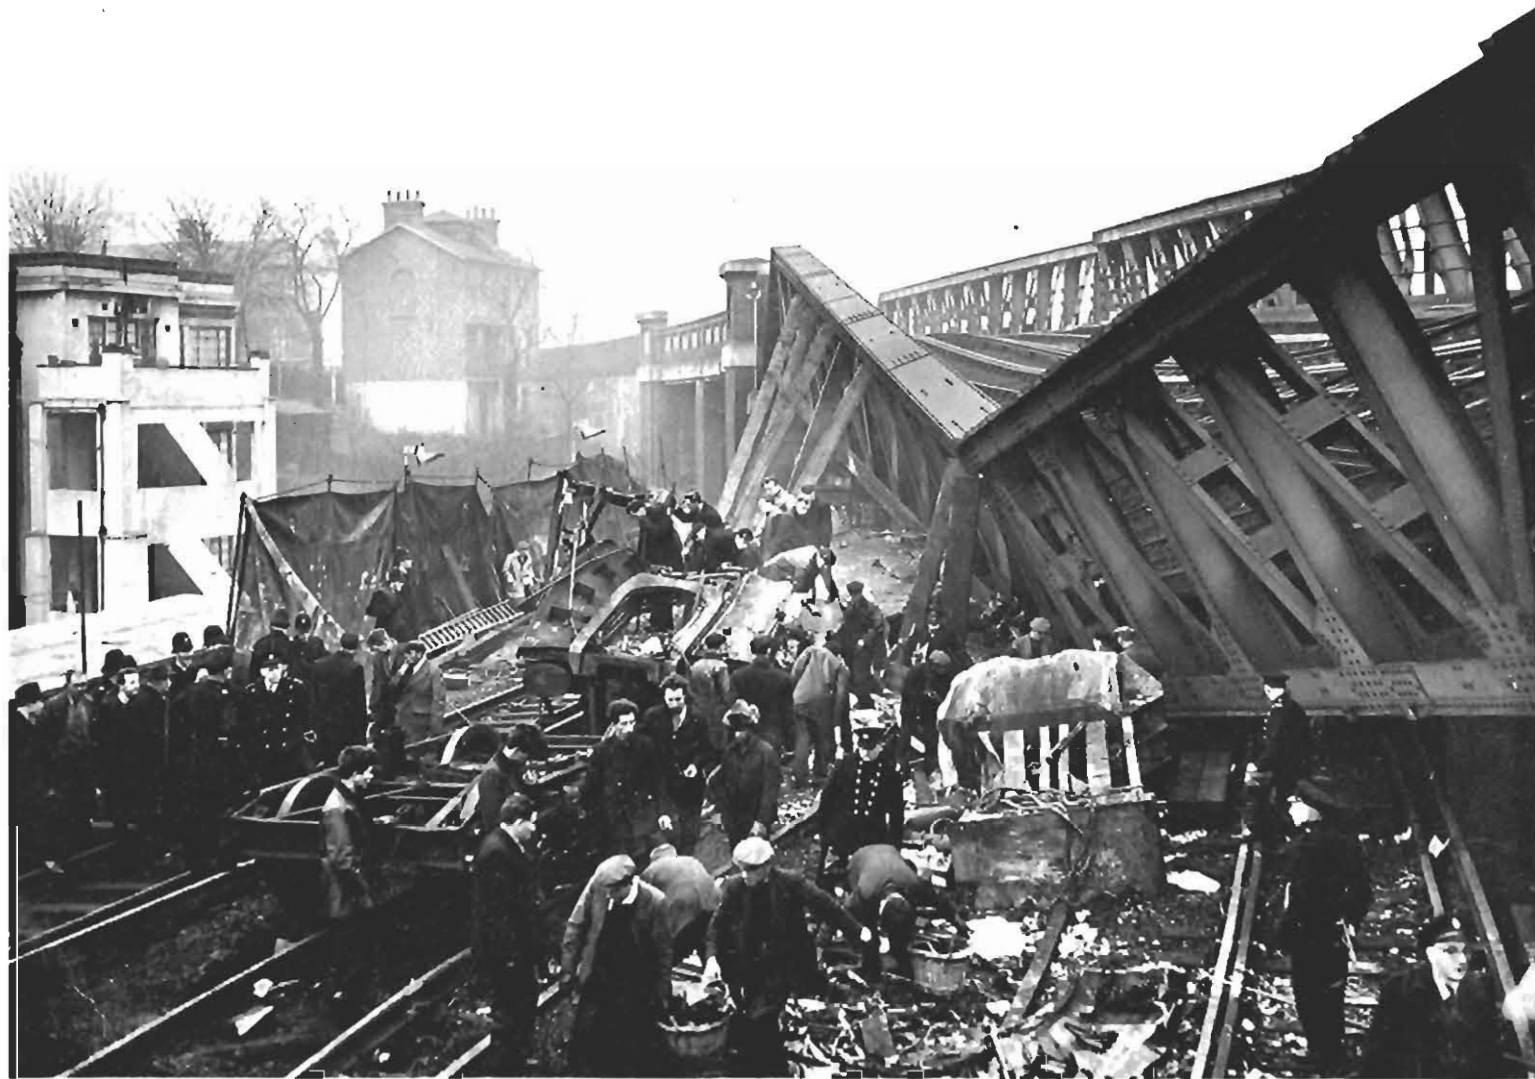
The two girders subsided at once on to the train below completing the destruction of the leading coach and crushing the second coach and the leading half of the third. About two minutes later, the 5.22 p.m. 8-coach electric train from Holborn Viaduct to Dartford, which was moving slowly on to the bridge towards a signal at Red, was stopped very promptly by the motorman when he saw the girders at an angle; this train was neither derailed nor damaged, but the leading coach was tilted. The electric current was cut off from all the tracks except the Down Nunhead line by the opening of the circuit breakers at the neighbouring substations on heavy short circuit at the instant of the collision; a minute or two later the circuit breakers feeding the Down Nunhead line were opened by the supervisory control. There was no fire.

BRIDGE No. 111. AFTER THE ACCIDENT.

Considerable damage was done to the leading coach by its forcible contact with the tender as an immediate result of the collision, and the destruction of the body was completed by the crushing and shearing action of the girders as they came down while the coach was still moving forward. The underframe also was badly bent. It was difficult to be certain whether the next coach, open second No. 4377, was still moving as the girders came down on to it, but it appeared that vertical crushing had been mainly responsible for the destruction of its body, which was complete. All the wheels were derailed, and it has already been mentioned that the underframe of this coach was cut up during the removal of the fallen bridge. The leading half of the third coach, open second No. 4378, was also crushed and destroyed, and the leading bogie was derailed, but the rear half of this coach remained clear.

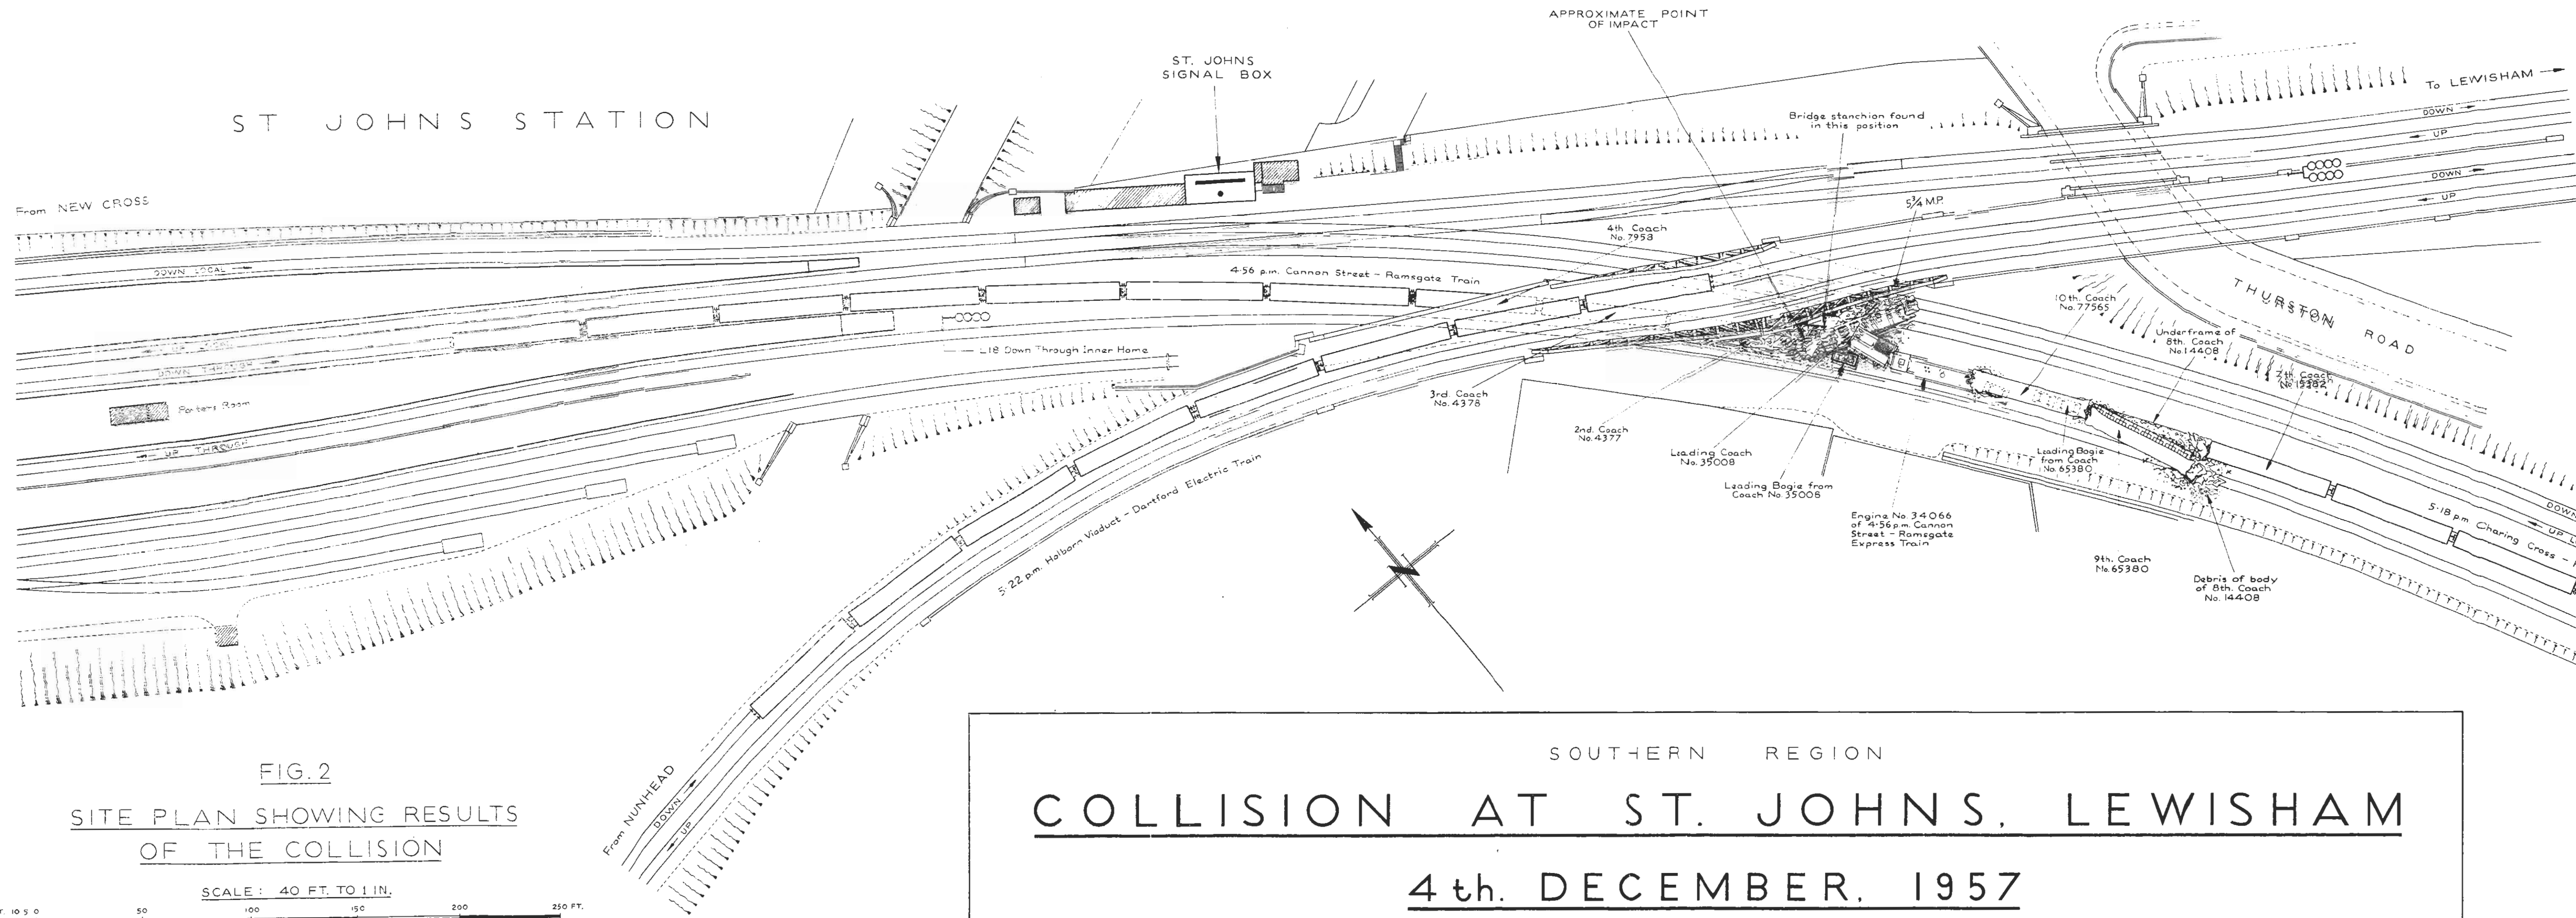
FIG. 2
SITE PLAN SHOWING RESULTS
OF THE COLLISION

The front of this coach was Buckeye coupled to the motor saloon brake, No. 14408 (the eighth coach), and the violence of the shock broke the steel casting of the front half of the coupler in a clean fracture. It seems that the rear half of the coupler, which was also broken, pushed in the upper part of the headstock in front of it to form a kind of ramp, over which the underframe and body of the ninth coach were driven to destroy the body of the eighth coach leaving the headstocks of the tenth and eighth coaches butted together.

In addition to the damage to the rear passenger compartment of the ninth coach, the motorman's compartment at the leading end was crushed, but the underframe of the eighth coach was left almost bare, and the body was thrown to the right as a crumpled mass of steelwork on to the adjacent Up Through line. The destruction of this coach was responsible for the great majority of the fatalities in the electric train. The leading (motor) bogie of the ninth coach was left behind under the front of the tenth, but its trailing bogie remained in place and was carried by its underframe on to the floor of the coach ahead.

The underframe of the eighth coach was driven for a short way beneath the underframe of the trailer No. 15382 (the seventh coach), but there was very little serious damage to that coach or to any of the leading six coaches.

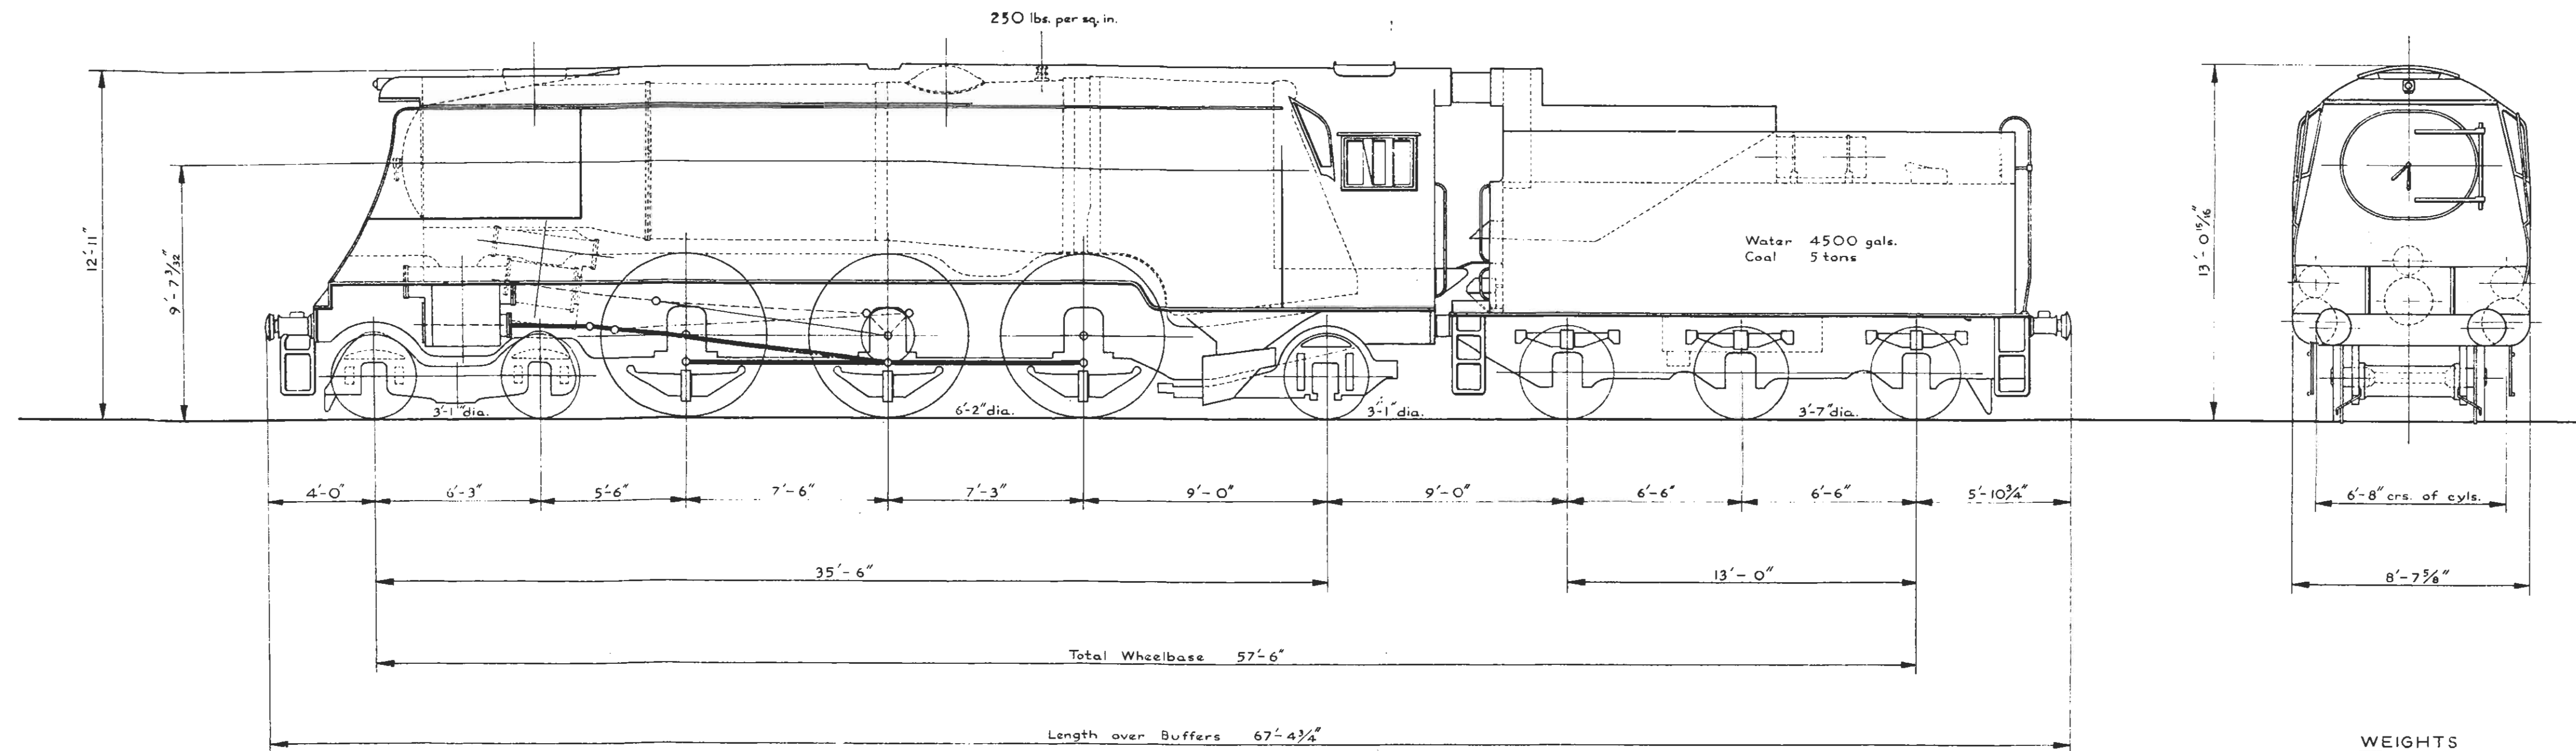
FIG. 3 ENGINE No. 34066 — BATTLE OF BRITAIN CLASS

3. The engine was No. 34066 of the "Battle of Britain" class with 4-6-2 wheel arrangement, and it was stationed at Stewart's Lane Motive Power Depot. It had run 357,391 miles since it was built at Brighton Works in 1947, and it was in very good general condition, having run 3,444 miles only since the last classified repair at Eastleigh Works in October 1957. The weight of the engine in working order with six-wheeled tender was 128½ tons.

7. The engine of the Ramsgate train was not derailed, but the front buffer beam and the main frames at the front end on both sides were bent, and the centre steam chest casting was broken. There was also considerable damage to fittings and platework at the front end. The rear buffer beam was also bent and there was some damage to the intermediate drawgear. There was no collision damage to the boiler, and a driver and fireman who had been travelling with the motorman of the electric train, acted promptly to throw out the fire and smother the remains of it with ballast as a precaution against overheating of the fire box plates. Mr. G. A. Weeden, District Motive Power Superintendent, Stewart's Lane, mounted the footplate approximately four hours after the accident. He found the regulator closed, with the reverser in forward gear at between 40% and 50% cut-off. The driver's vacuum brake valve handle was in the fully applied position, and the blower valve was closed.

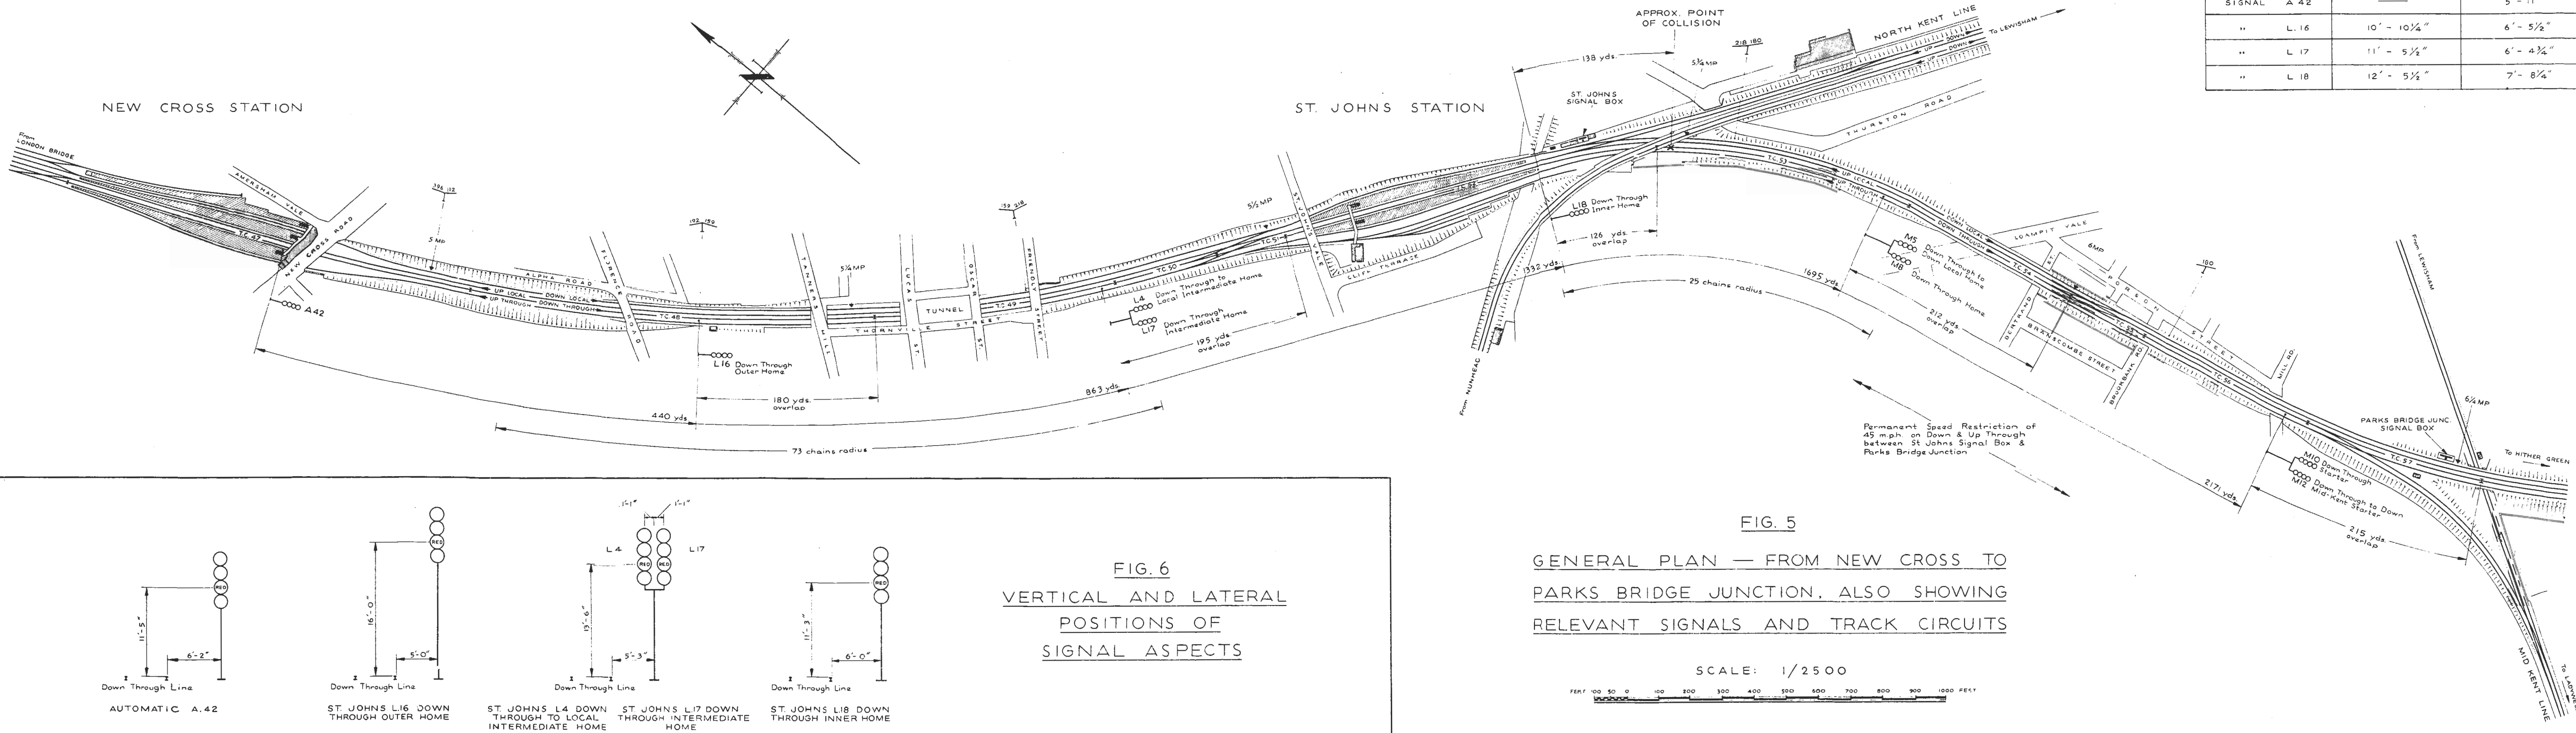
FIG. 5

14. Fig. 5 is a general plan of the route from New Cross through St. Johns to Parks Bridge Junction; it also shows the relevant signals and track circuits and other information. It will be noted that there is a double line junction at St. Johns, between the Local lines only and the North Kent line via Lewisham, which continues on the straight. At this point the four main tracks begin to curve to the south through the bridge which was brought down, and then become straight for some way ahead. At Parks Bridge there is a double line junction, also facing in the Down direction, between the Through lines only and the Mid Kent line which runs via New Beckenham to Hayes.

It should be noted that, after the length of straight through New Cross station, there is a left-handed curve of 73 chains radius through the cutting to St. Johns, and that the Down Through line, on which the Ramsgate train was running, is straight again through the St. Johns platform. Beyond the platform, all the four tracks pass through the bridge on a right handed curve of 25 chains radius with 4 in. cant, on which there is a speed restriction of 45 m.p.h.

26. From the right hand columns of Table 1 and the distances shown on Fig. 5, it will be noted that before signal L.17 can clear to Y to let a train forward to L.18 at R, track circuit No. 52 must be clear, giving a clear distance of 126 yards beyond signal L.18. This distance is termed the overlap, and such comparatively short overlaps are characteristic of this installation where prevailing speeds are moderate and the density of the traffic and the comparatively close headway requires that the signals should be cleared at the earliest possible moment behind a preceding train.

It will be noted from the inset to Fig. 5 that there is plenty of room for the simple signal posts in the wide space between the Down and Up Through line, but none between the Down Through and the Up Local lines, and to have brought the signal aspects to the left of the Down Through would have required fairly elaborate cantilevered gantries. I understand that at the time of installation, when most of the engines were driven from the right hand side, the signals were sited as nearly as possible to the driver's or fireman's eye level in order to give the best view in the prevailing conditions where curvature and overbridges had to be taken into consideration.
