The train collision at Ladbroke Grove 5 October 1999

A report of the HSE investigation

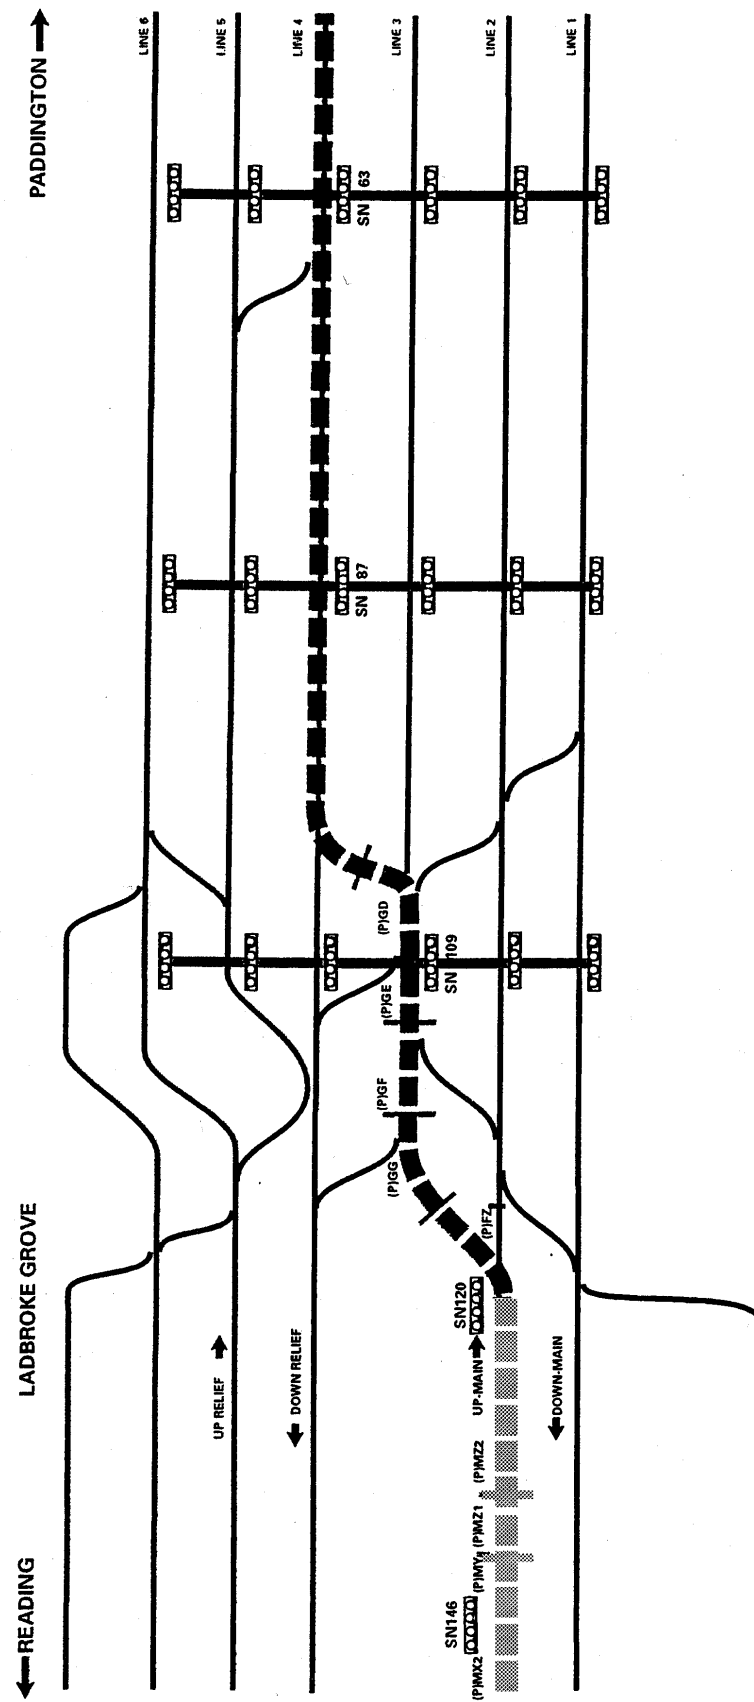
Appendix 2: Diagram of collision site

Coach B1, caused the latter to topple over. When the vehicles came to a halt, the leading power car of the HST had travelled approximately 90 metres from the point of collision, with the HST trailing power car and Coaches A-G travelling approximately 170 metres before coming to rest (see diagram at Appendix 2 for details).
