RAILWAY ACCIDENT

Report on the Collision that occurred on 11th December 1981 near Seer Green

IN THE
LONDON MIDLAND REGION
OF BRITISH RAILWAYS

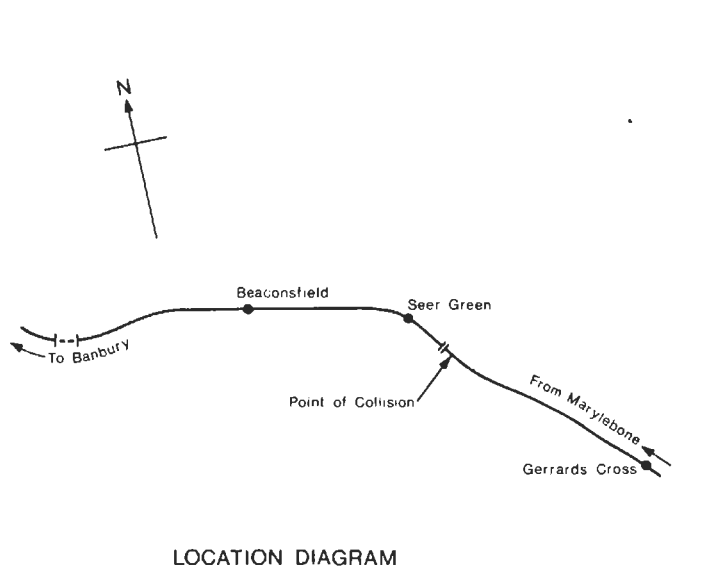
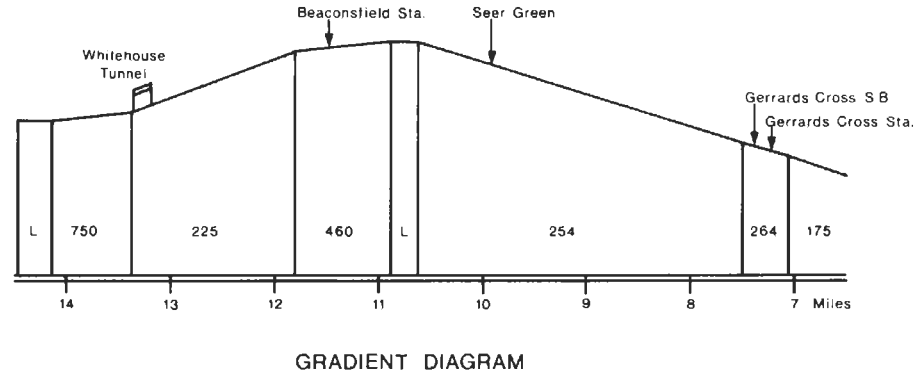
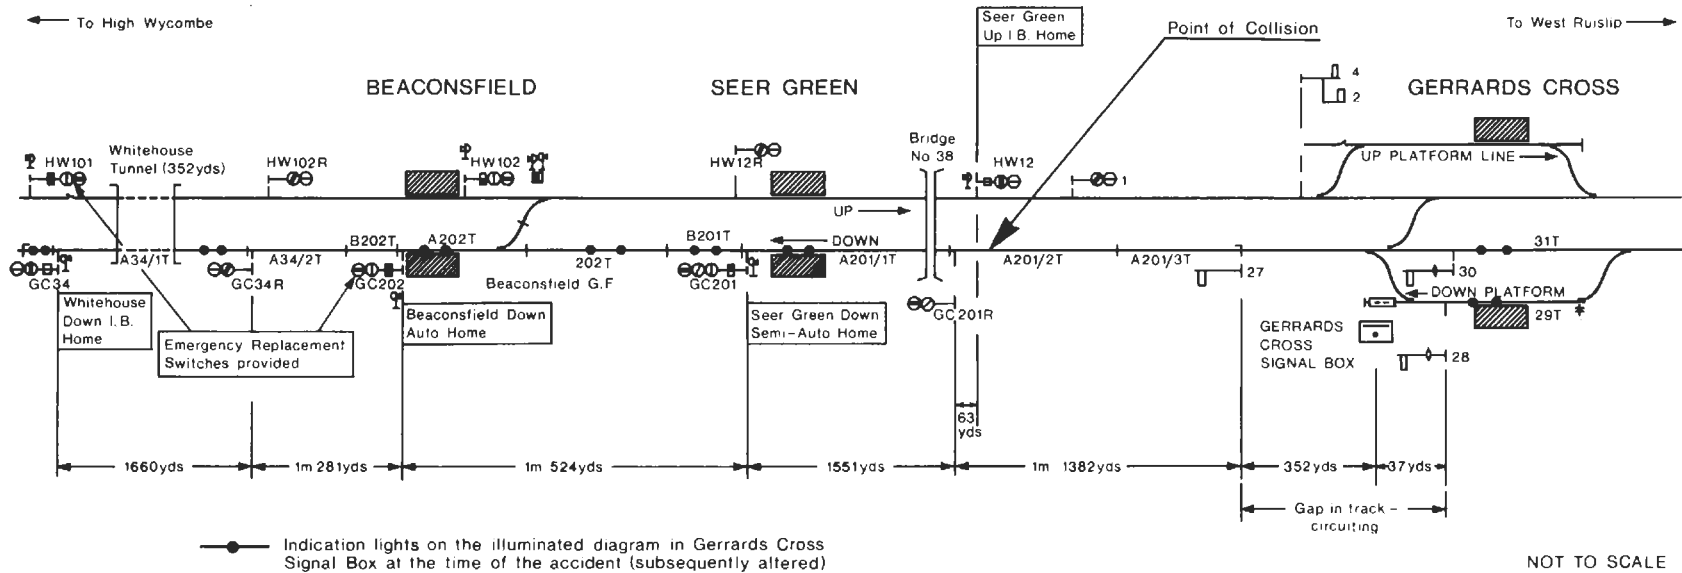
FIGURE 1

4. Gerrards Cross Signal Box has a former GWR mechanical stud frame converted to vertical tappet locking. There are 33 levers, of which 29 are working. Standard WR pegging block is provided on the Up and Down lines and there is a block switch. An illuminated track-circuit diagram is provided, mounted above the block shelf. At the time of the accident, the lights showing track circuit occupation were situated as shown in Figure 1.

SEER GREEN: 5B61 0725 MARYLEBONE TO PRINCES RISBOROUGH
AND 2B64 0731 MARYLEBONE TO BANBURY IN
COLLISION: 11 DECEMBER 1981

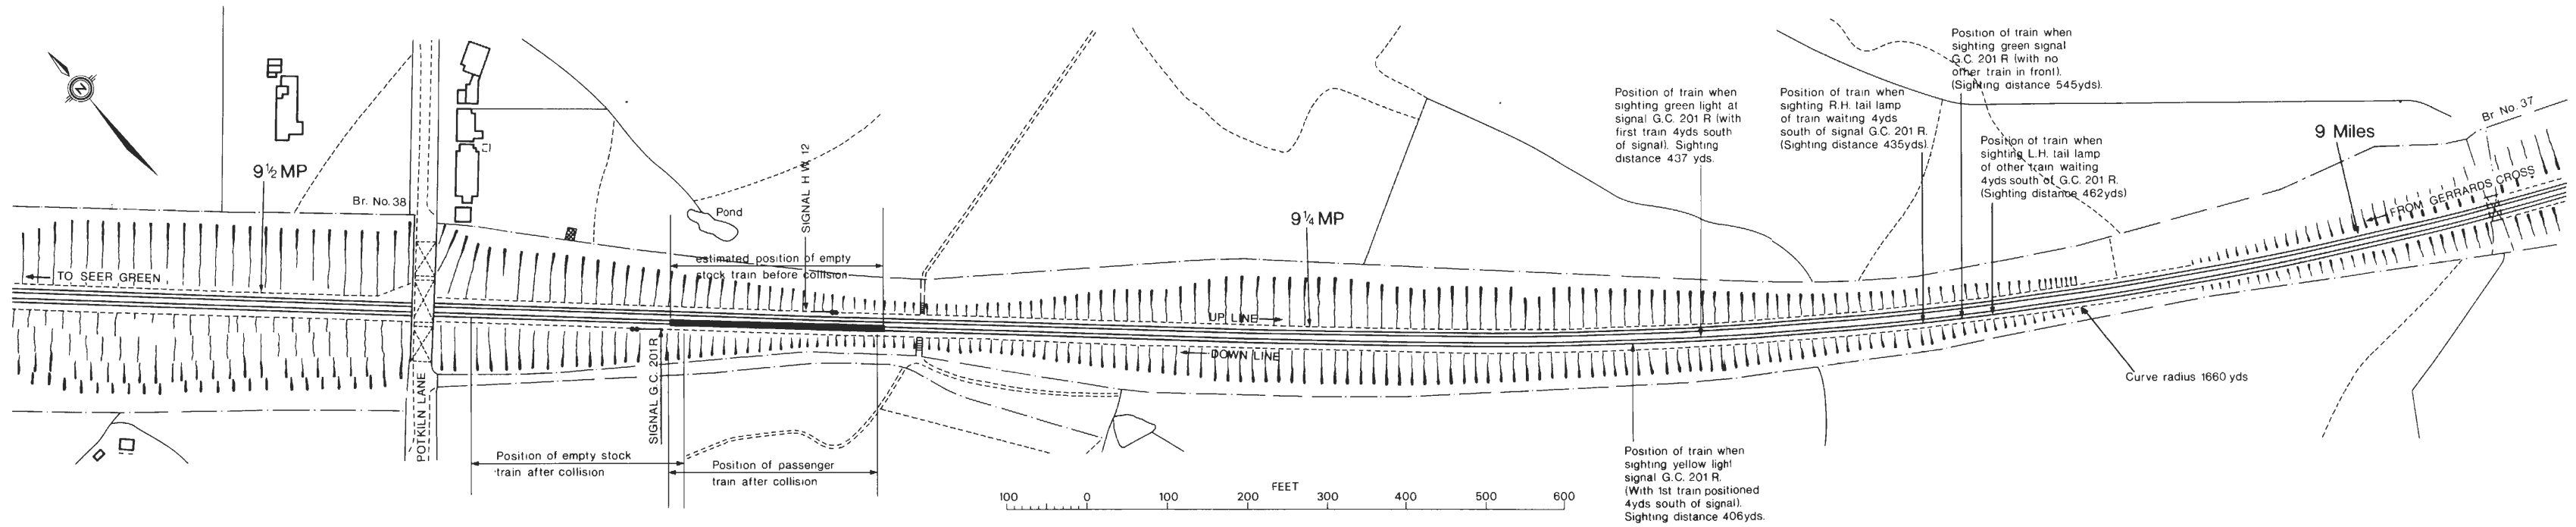
2. Gerrards Cross Signal Box is not continuously manned and when it is closed Absolute Block working applies on the Up and Down lines between West Ruislip and High Wycombe, the signal boxes to the south and north respectively. With Gerrards Cross Signal Box in operation, Absolute Block working applies between West Ruislip and Gerrards Cross, and between Gerrards Cross and High Wycombe. On the Down line, between the latter two signal boxes, there is an Intermediate Block section which extends from the automatic Signal GC 202 to the IB Home Signal GC 34, and to the rear of this section there are two other signal sections the entrances to which are controlled by Gerrards Cross Starting signal (27) and semi-automatic Signal GC 201; the whole of the area being under the control of the Gerrards Cross signalman. There are similar sections on the Up line under the control of the signalman at High Wycombe. The Down line is continuously track-circuited from West Ruislip as far as the overlap of Signal GC 34, apart from a short gap between Signals 28/30 and Signal 27 at Gerrards Cross. Standard BR AWS is fitted on both lines. All the Stop signals are provided with telephones, those on the Down line communicating with Gerrards Cross and those on the Up line with High Wycombe. Figure 1 at the back of the report shows the line between Gerrards Cross and High Wycombe in diagrammatic form together with the location of the signals, track circuits, etc. Figure 2 shows the detailed layout in the area of the collision.

PLAN SHOWING THE POSITION OF THE TRAINS BEFORE AND AFTER THE COLLISION
