RAILWAY ACCIDENTS

REPORT ON THE COLLISION

which occurred on
4th December 1957

**ST. JOHNS STATION
LEWISHAM**

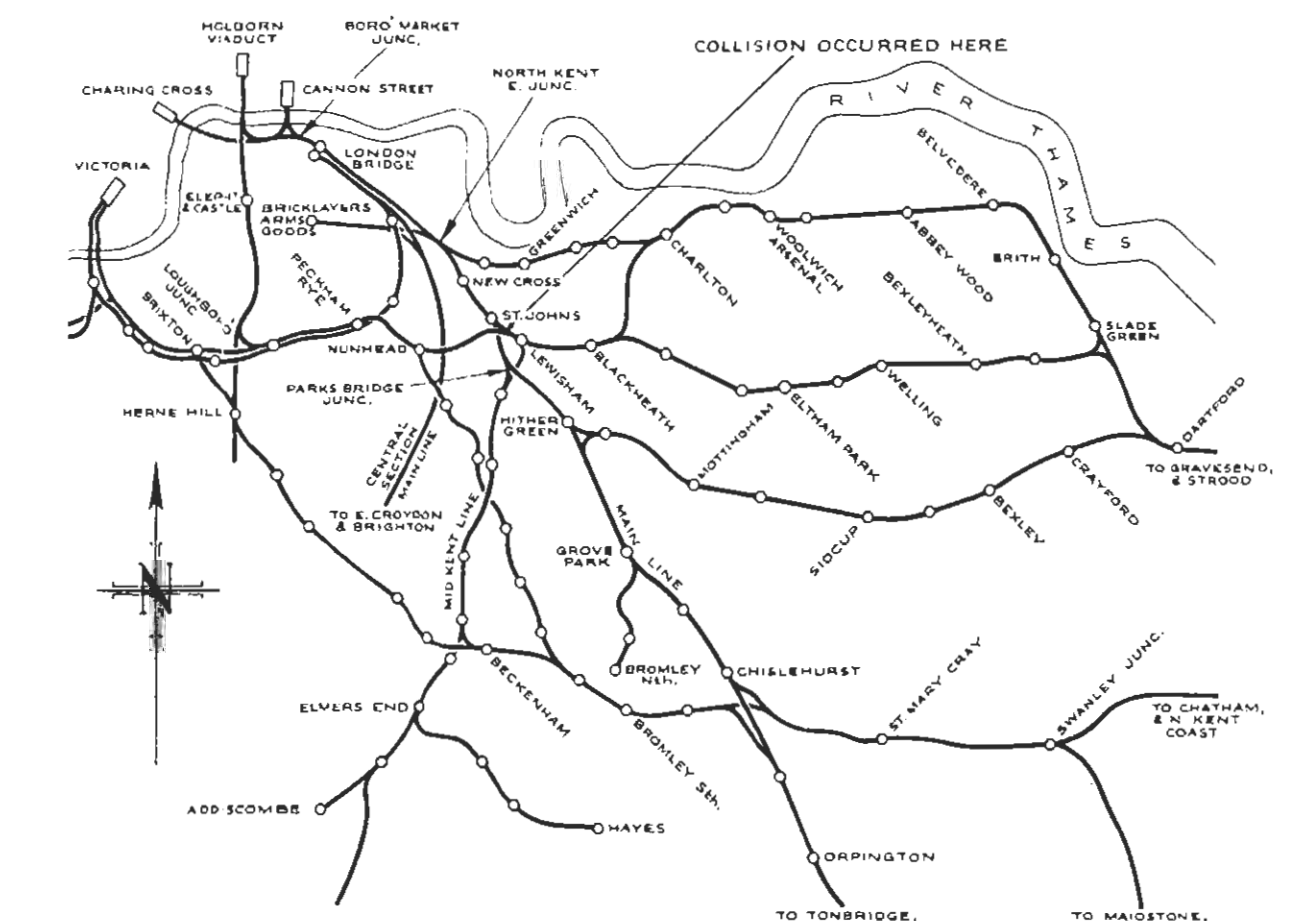
FIG. 2
SITE PLAN SHOWING RESULTS
OF THE COLLISION

6. It will be seen from the site plan, Fig. 2, that the collision occurred on the Down Through line, which is on a right handed curve of 25 chains radius through the acutely angled overline bridge. The point of impact was just at the country side of the bridge nearly opposite to the 5¾ mile post from Charing Cross, and 138 yards beyond the St. Johns inner home signal, No. L.18, which the Ramsgate train had passed at Red. The Hayes electric train was standing with its brakes on, a few yards back from the next signal, the Parks Bridge Junction home No. M.8.

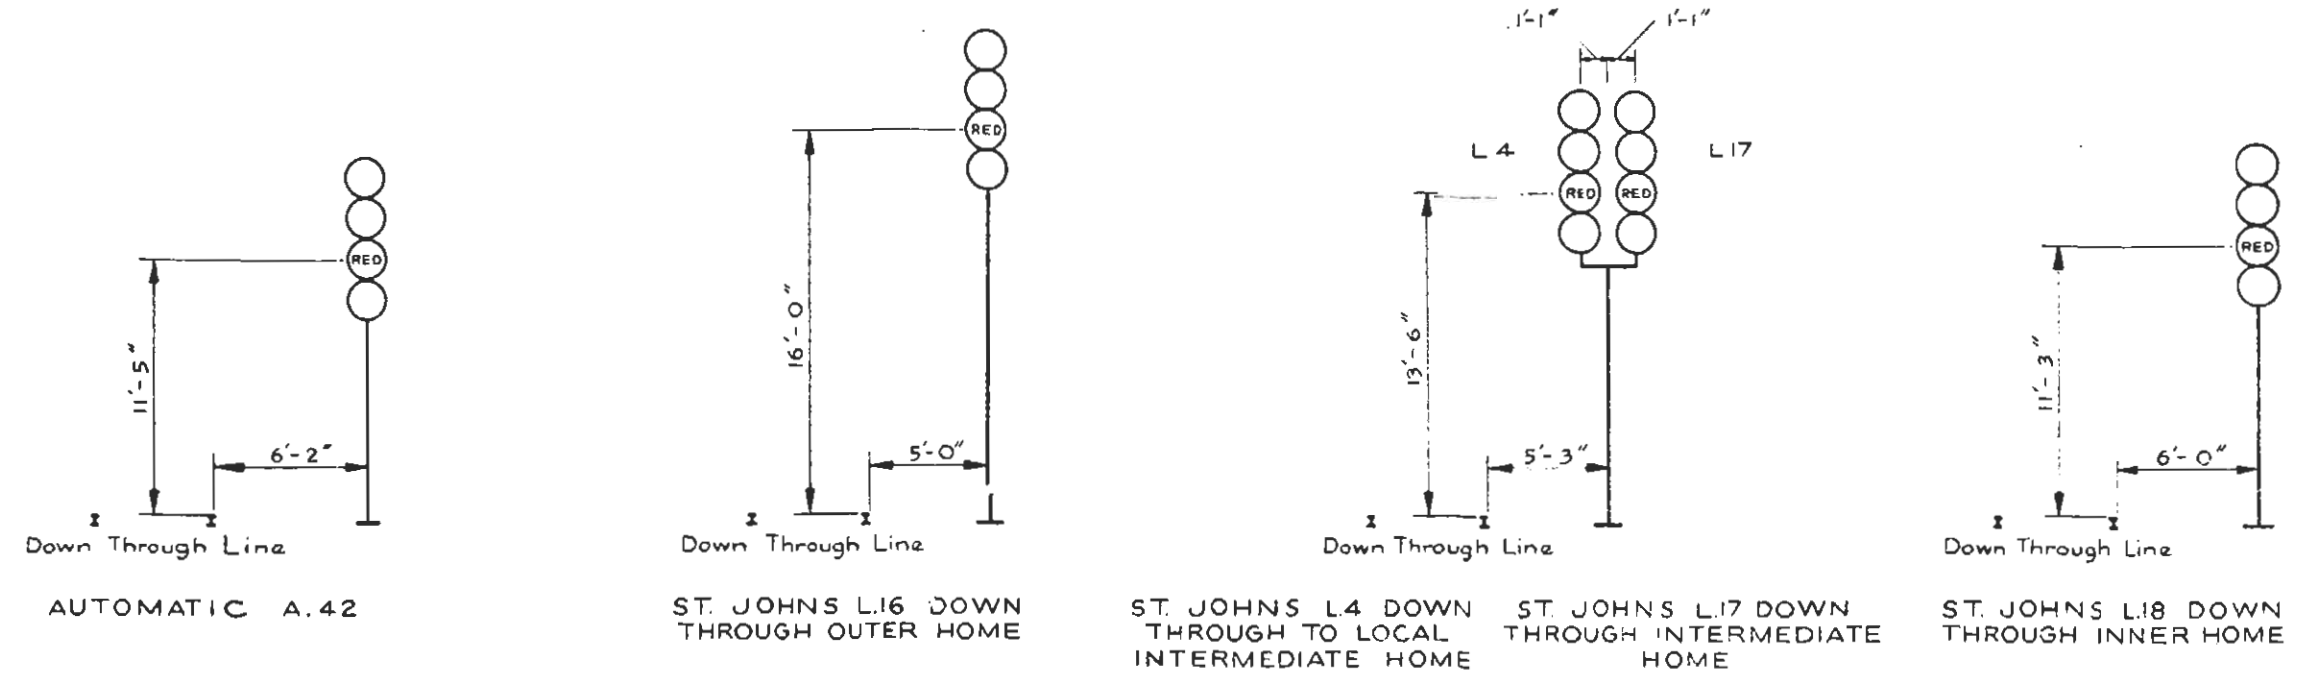
FIG. 6
VERTICAL AND LATERAL POSITIONS OF SIGNAL ASPECTS

30. The crucial signals in this case were the automatic A.42 at New Cross and Nos. L.16, L.17 and L.18 of *St. Johns* box. They are of the multi-lens type, and the aspects are arranged vertically, with the Red aspect the lowest but one of the four. Unlike the preceding 13 signals from Cannon Street, which are sited on posts or overhead gantries in the normal position to the left of the line, these four signals, and the Down Through signals Nos. M.5/8 and M.10/12 of *Parks Bridge Junction* are sited on the right hand side. Fig. 6 gives the relevant dimensions of the first four signals in relation to the Down Through line.

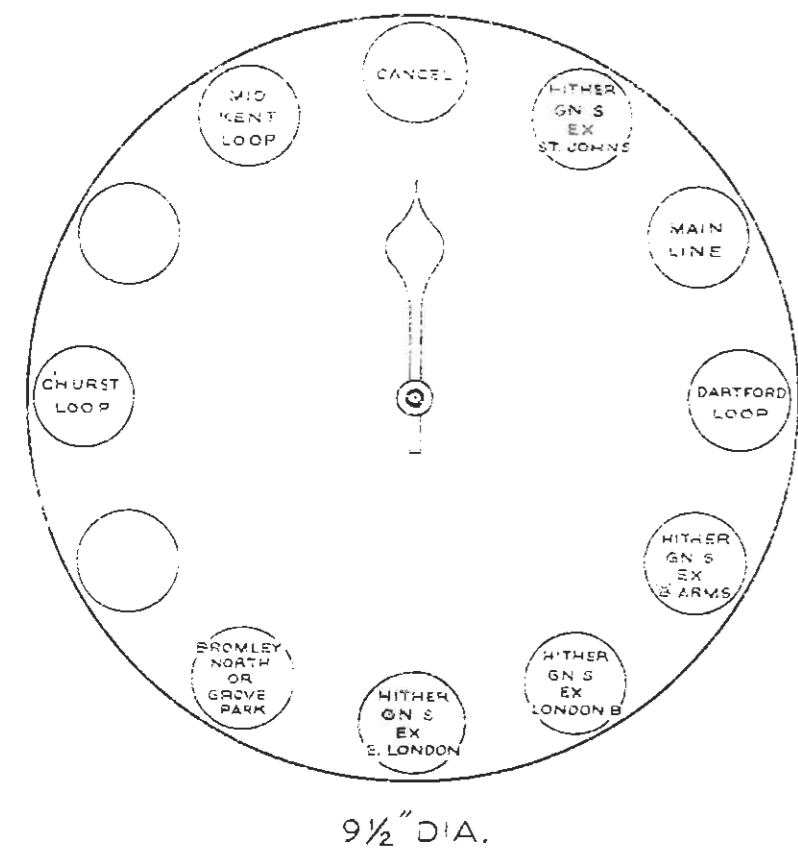
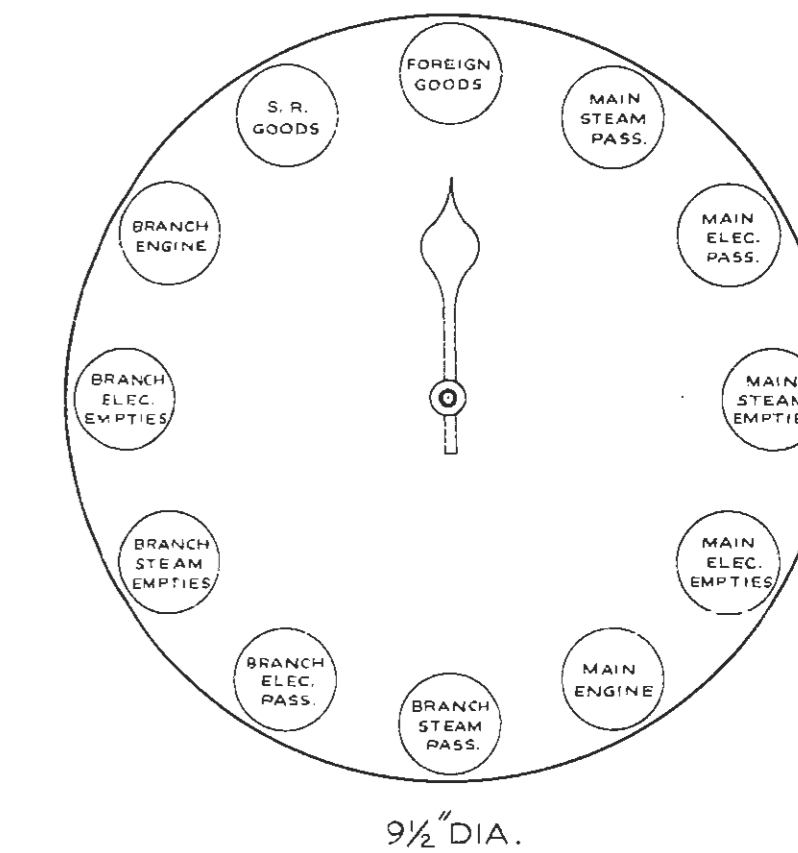
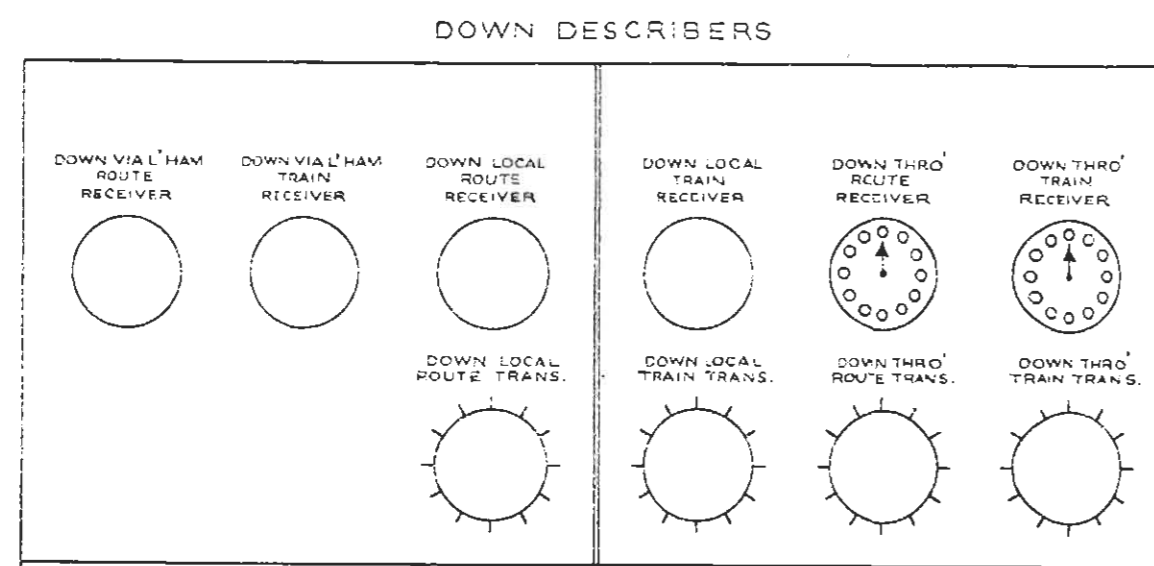
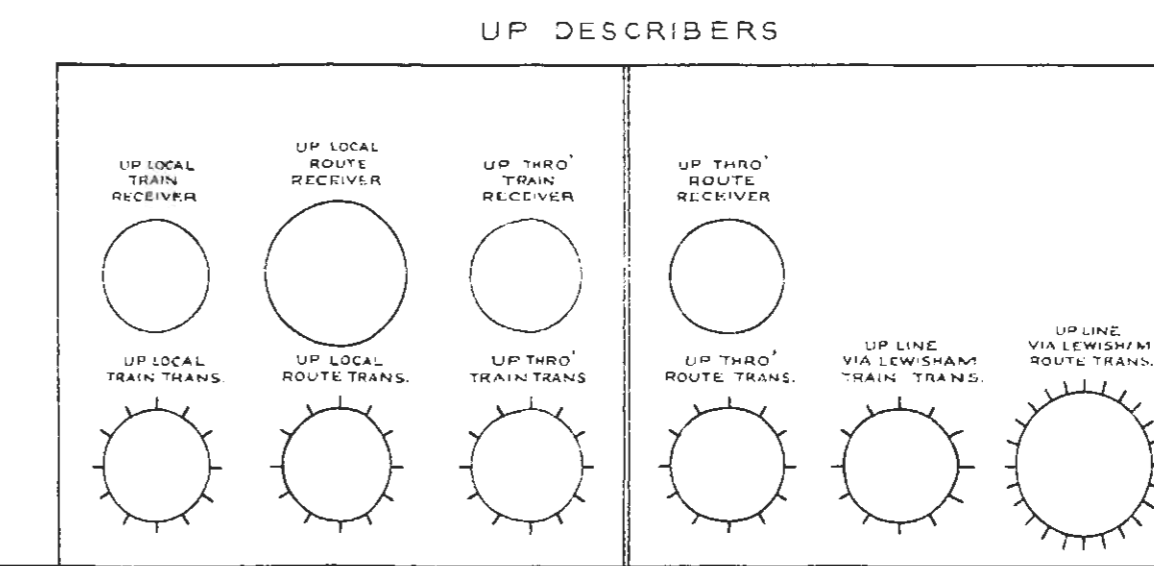
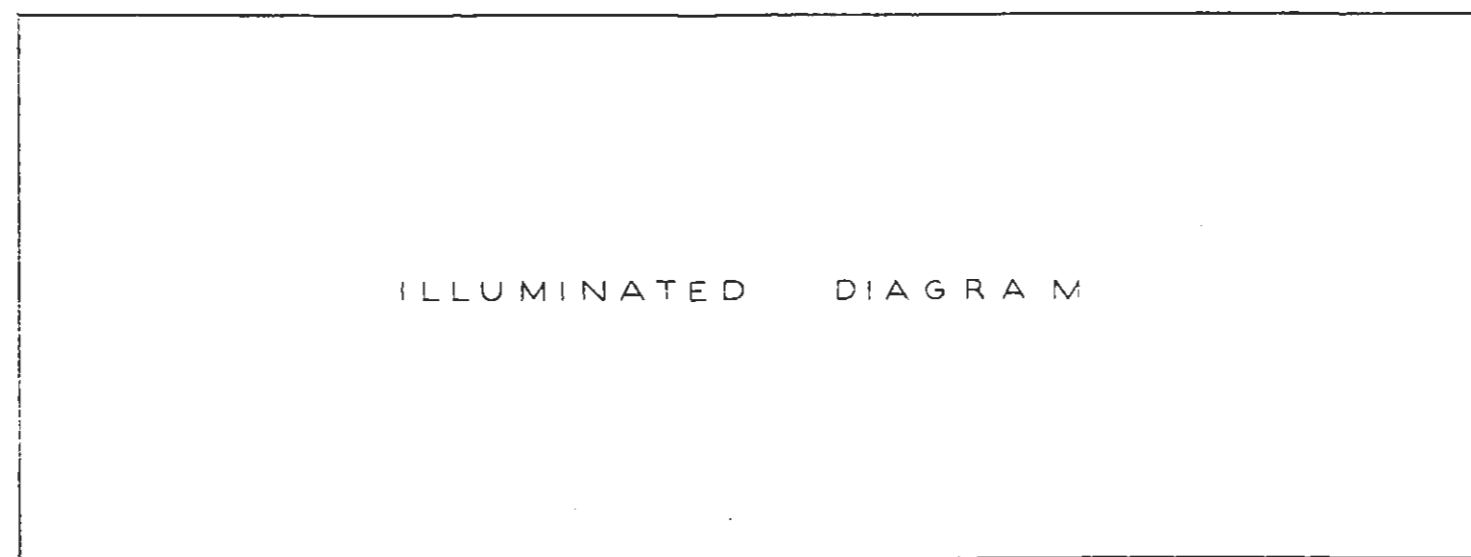
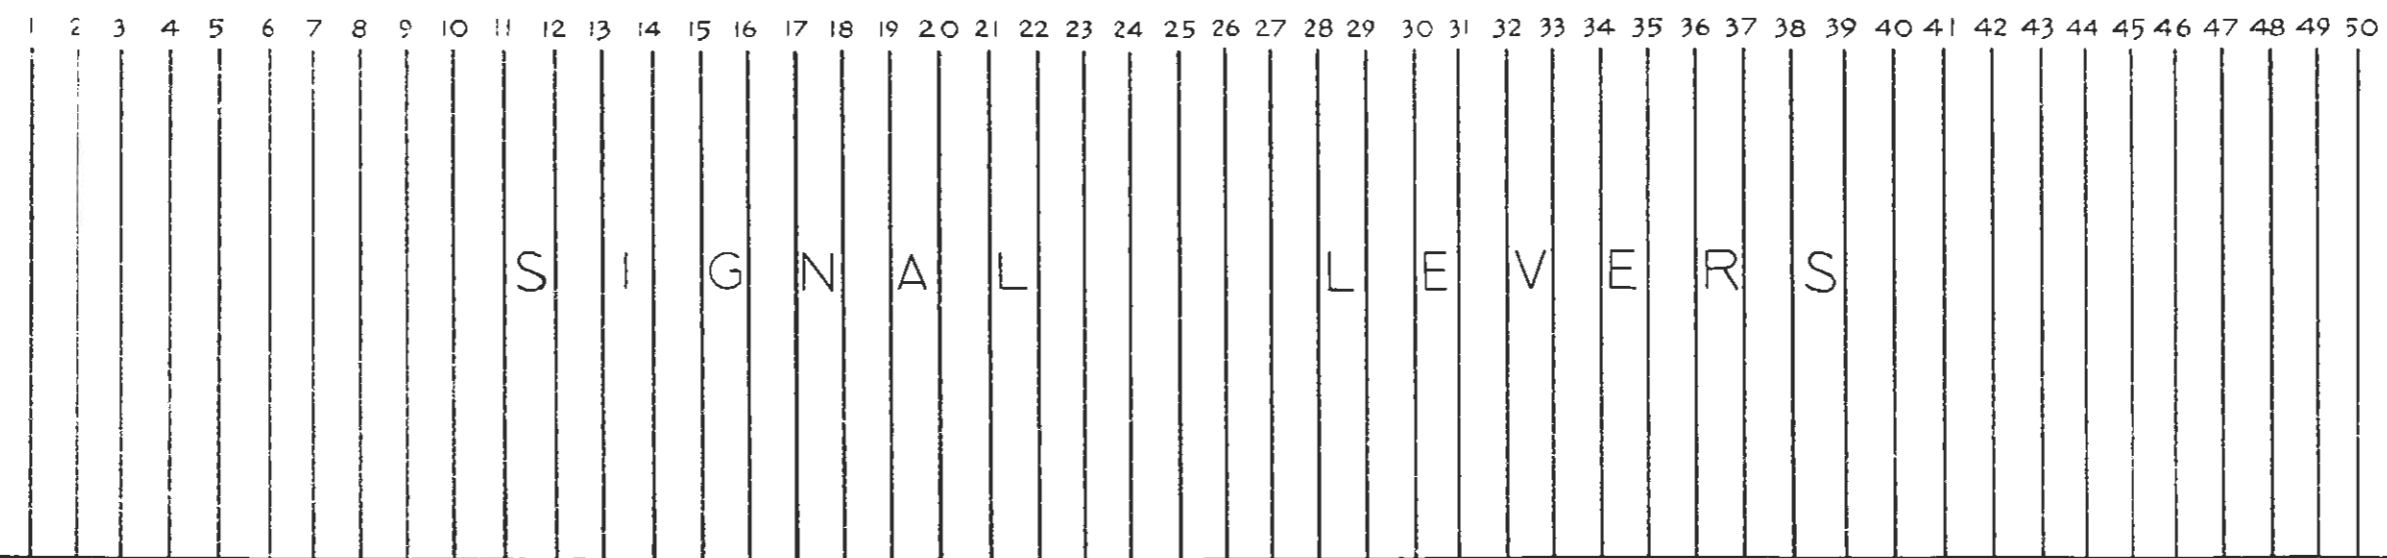
FIG. 7

18. With all the signal aspects under track circuit control there is no manual block working, and the trains are announced from one box to the next by Walker's pattern train describers—see the Appendix and Fig. 7. These train describers are of old-fashioned design, but they have proved very reliable over the years, and all the signalmen on this route are thoroughly accustomed to their working.
